COUNTDOWN WARKWORTH SUSPENDED POST-TENSIONED SLAB

SUMMARY

The Countdown Warkworth project is located on a 5,500m² site between Mill Lane and Neville Street in Warkworth. The project consists of a 3,700m² supermarket, 310m² adjoining retail shops and a truck delivery area all on a suspended post tensioned floor structure above a basement car park. Due to the highly complex nature of the suspended slab, which included varying span sizes to accommodate the basement car parking layout, multiple services penetrations and steps to slabs and beams a post tensioned floor was used. This paper will focus on the design and construction challenges.

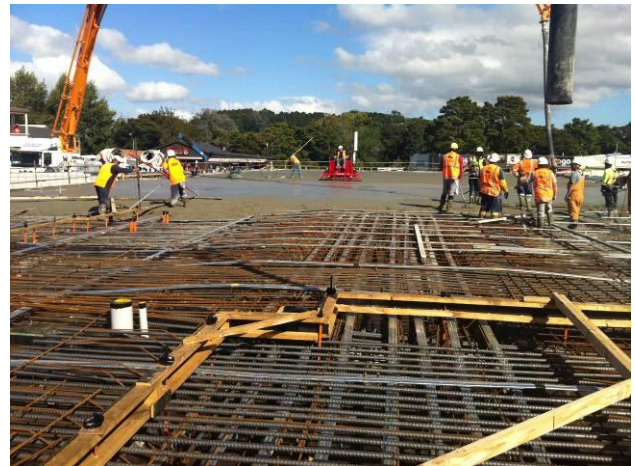
Figure 1: Countdown Warkworth Pour No 1

The slab was constructed in three separate pours using a total of 1,650m³ of concrete, 37.5t of post tensioning strand and 85t of reinforcing.

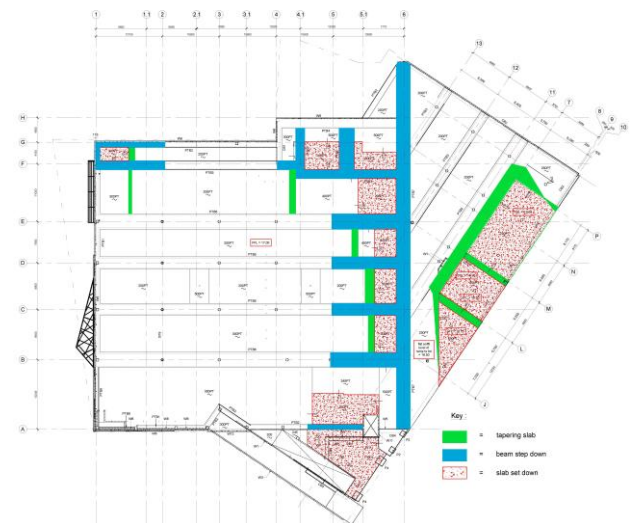
Figure 3: Suspended Post-tensioned Floor Plan

A one-way spanning slab and banded beam arrangements was proposed. Slabs ranged from 200mm to 300mm in thickness, banded beams ranging from 500mm to 600mm deep and 600mm to 2400mm in width.

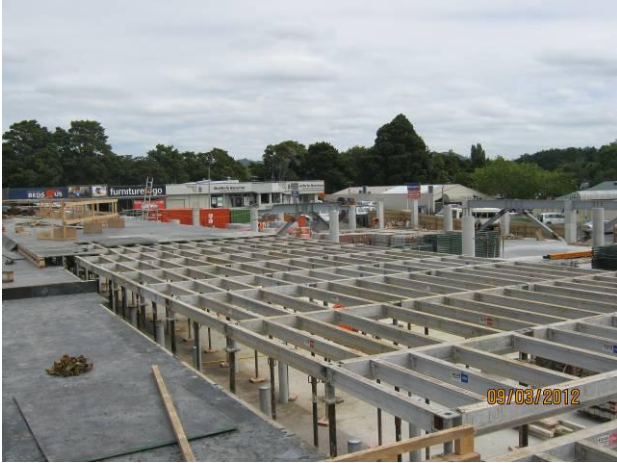
Figure 8: Ischebeck Formwork System

Restricted access on site dictated that the conventional table formwork would not be appropriate as a means of supporting the suspended deck, and as a result the Ischebeck formwork system was selected which is a well proven slab forming system with aluminium beams and standards providing for fast installation and removal without the need for a crane. The prop head also incorporates a double nut system that enables the plywood to be removed without disturbing the propping.

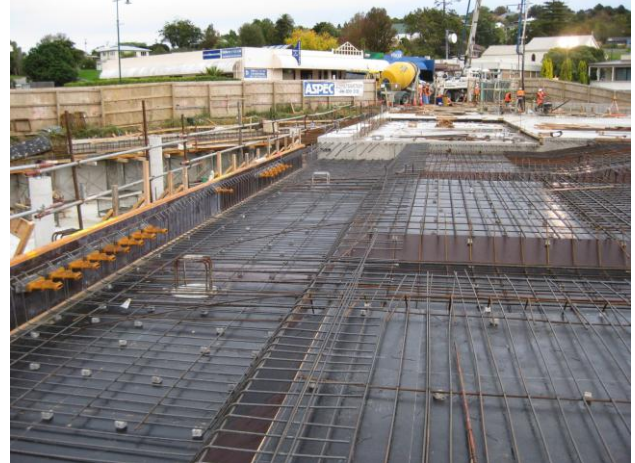
Figure 9: Complexity of Formwork

A total of 3,500sq.m of Ischebeck formwork was used which was enough to set up Pour 1 and Pour 2. The complexity of the set-downs in the slab was reflected in the time frame to prepare each slab which was ranged between 3 and 4 weeks.

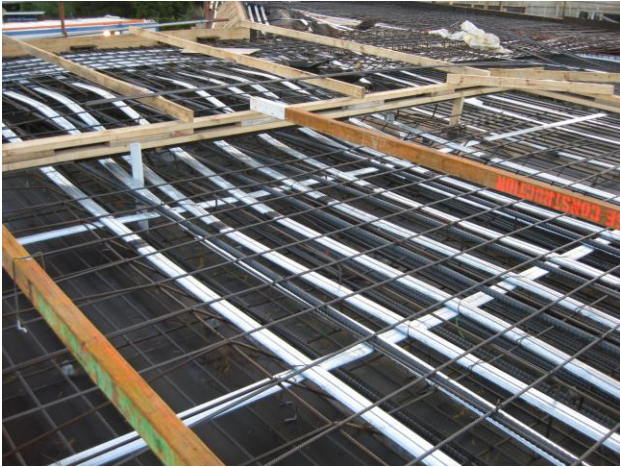
Figure 10: Post-tensioning and Reinforcement

Once the formwork was erected and edge boards installed with pre-formed slots for the strand, the post-tensioning anchorages were bolted in place. The reinforcing steel installation commenced at the same time with a primary focus being the bottom mat to the beams and slab.

It was imperative that material placement on the formed deck was well planned and coordinated to ensure the duct installation could proceed in both directions. After the duct were placed and taped, the strand for the beam tendons were installed, followed by the strands for the slab tendons.

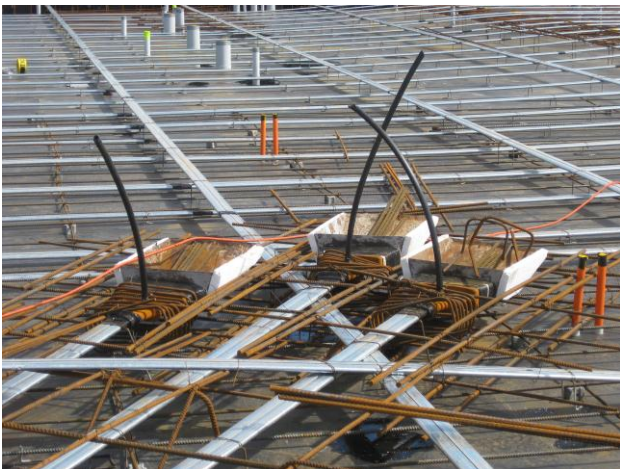
Figure 11: Stressing Pans

Where access to the perimeter of the slab was not possible, pans were used within the body of the slab to enable the stressing operations to take place.

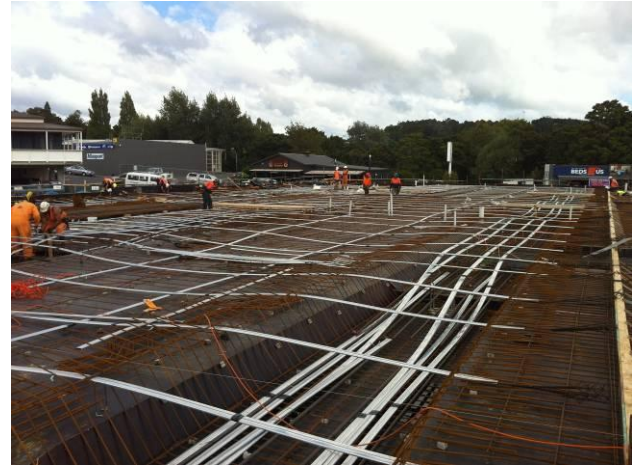
Figure 12: Post-tensioning & Reinforcement

The installation of the reinforcement and post-tensioning for each pour was completed over a 3 week period for each slab with a combined workforce of 20 men.

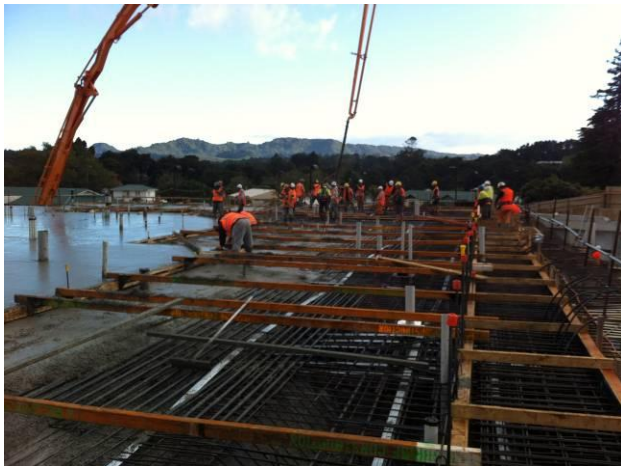
Figure 14: Concrete pumping and placing

Concrete for the second and largest pour was supplied from Holcim's Avondale plant and Allied's Silverdale plant. With a combined fleet of 48 trucks servicing two boom pumps, a constant 125m³ per hour was supplied for the first 2 hours and the overall delivery / placement rate achieved was 105m³ per hour.

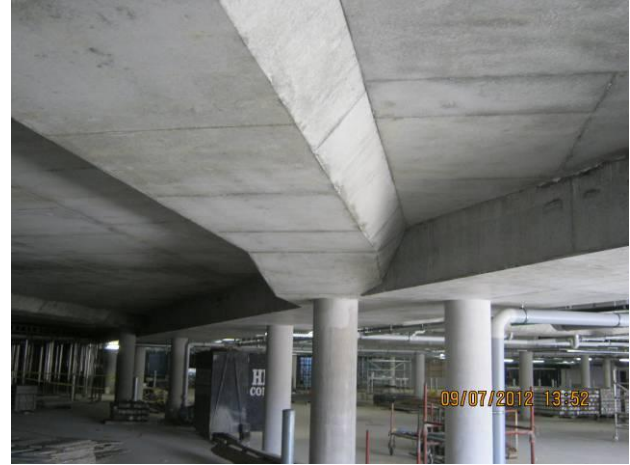
Figure 15: Recently stripped floor

The slab surface achieved a FM3 flatness using free screeding. A combination of good vibration and quality plywood resulted in a very consistent finish to the soffit of the concrete slab.

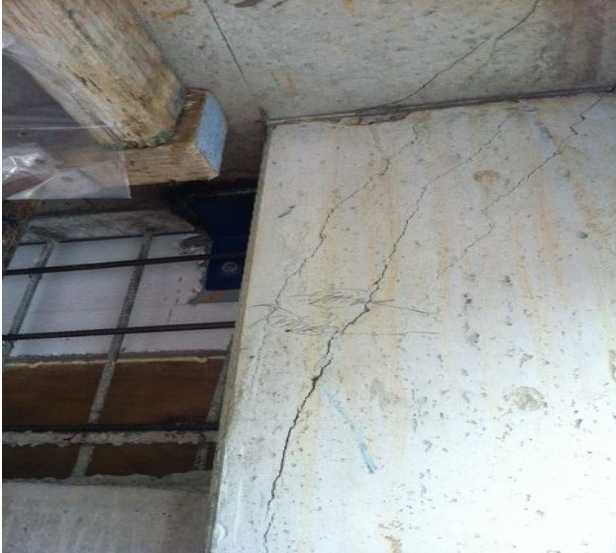
Figure 16: Restraint cracking within column

Restraint cracking occurred in a column due to insufficient allowance for movement from elastic shrinkage and early creep.
