WATERVIEW CONNECTION GROUND ANCHORS AND SOIL NAILS

David Sharp¹
(BE Hons, M.IPENZ)

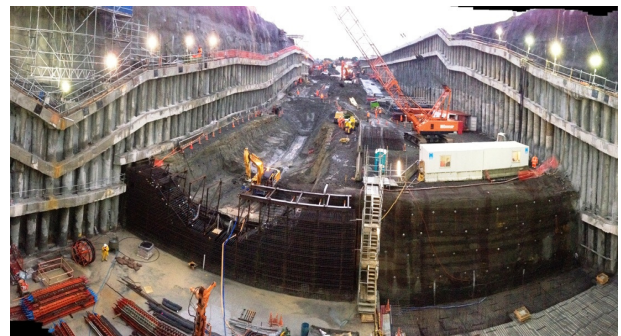
Figure 1: Southern Approach Trench

The Southern Approach Trench (SAT), the eastern approach to the tunnel and initial launch area of the 14.5m diameter tunnel boring machine (TBM) is approx. 45m wide and up to 30m deep near the front face. There is a great variance in the geology of the area, which dictated the construction methodology and the design of the trench retaining system.

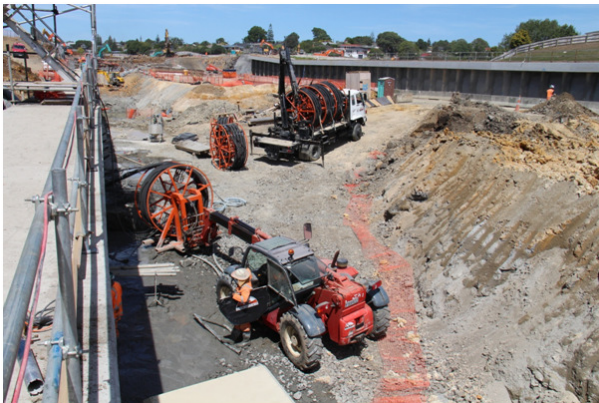
Figure 2: Anchor Installation Equipment

Additionally, with space being a premium and anchors weighing in excess of 500kg (meaning manual lifting was not an option), alternative methods for lifting the anchors had to be considered in-lieu of traditional craneage techniques. Grouting Services (GSL) utilised in-house expertise to develop an anchor carousel frame and hydraulically-controlled rotational drive unit to allow the anchors to be safely installed without the use of a crane.

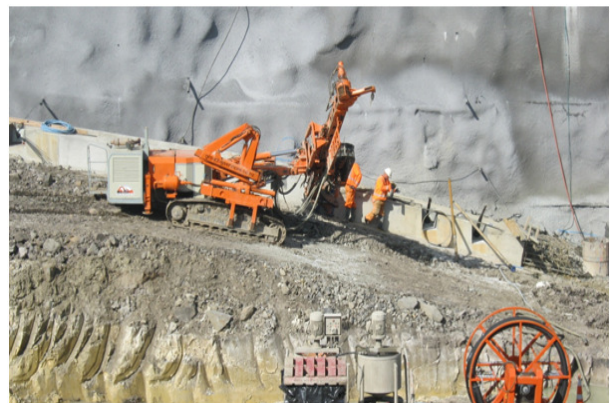
Figure 3 shows the proprietary anchoring rig designed with a swing boom, super high pull back (15tons) and high-torque rotator (up to 4000kgm torque). The double rotation head facilitates continuous double drive drilling with casing and rods.

Figure 3: Specialist Anchor Drilling Equipment HD180 Anchoring Rig

Overlying the TG and ECBF was a basalt layer of varying competency. To support the gantry crane used to re-build, and eventually dismantle the TBM within the SAT, 32-No double corrosion protected multi-strand anchors were installed at a 5° inclination into the basalt layer. The anchor holes were drilled to 15m with a 200mm down-the-hole hammer.

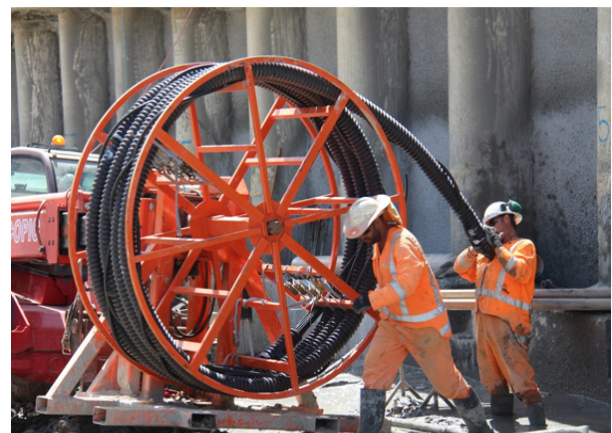
Figure 4: Anchor Carousel

The completed anchors were coiled onto a carousel ready for delivery to site for installation. The use of the carousel at this stage of the project added a further quality control step in the process and ensured all 431-No anchors were the correct length, contained the correct number of strands and were installed in the correct location.

The use of the anchor carousel system developed specifically for this project eliminated the need for heavy straining and reduced the time taken to install anchors.

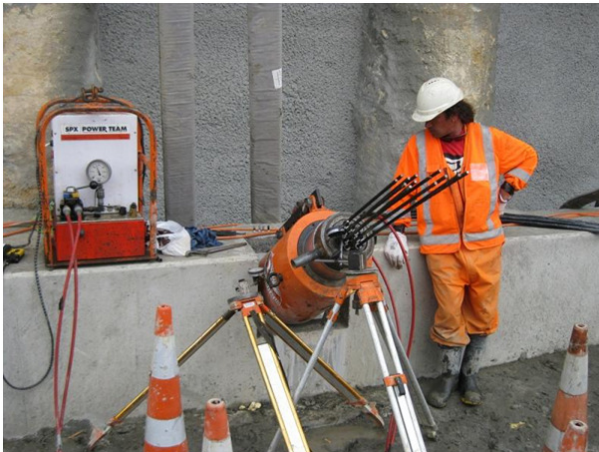
Figure 5: Stressing Set Up

The testing criteria for the anchors saw every anchor receive an acceptance test equivalent to 150% of the working load over 2-loading cycles. An initial load equal to 10% of the working load was applied to bed in the anchor and testing system, and allow the jack to stabilise. The load was held steady at each increment (and decrement) and maintained to ensure a variation of no more than 2kN was observed from the specified load.

Displacements at each load increment was recorded using a dial gauge atop a remote tripod and at the end of the second load cycle, the anchors were locked off at the prescribed working load.
