# WYNYARD QUARTER INNOVATION PRECINCT STAGE 1 BUILDING 5A GROUND ANCHORS

**David Sharp<sup>1</sup>**  
(BE Hons, M.IPENZ)

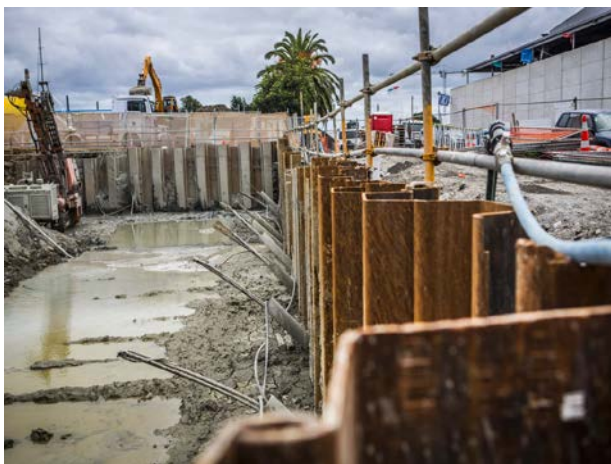
*Figure 1: Sheet Pile and Anchor*

The retention system comprised steel sheet piles driven to the required depth, tied-back by inclined ground anchors. Continuity of restraint between the anchors was provided by a reinforced concrete waler.

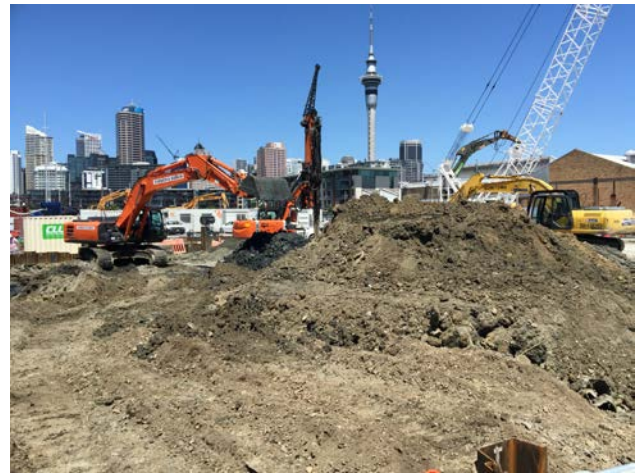
Figure 2: Site Pre-Excavation

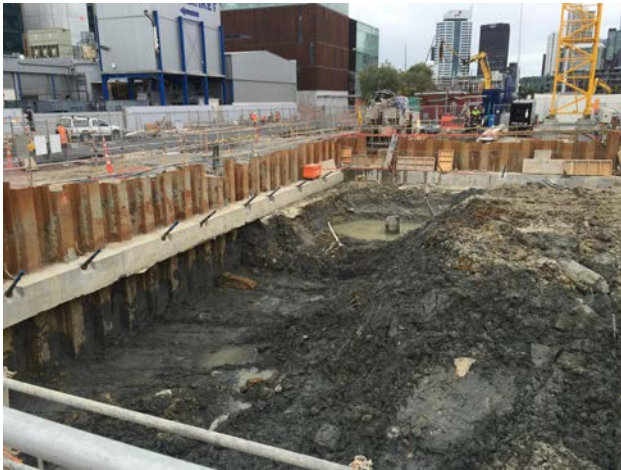
Figure 3: Concrete Waler Beam

Continuity between the anchors was to be provided by a reinforced concrete waler beam. The waler was designed to spread the maximum anticipated loads at the nominal spacing factored in accordance with NZS1170.

Steel corbel brackets to support the waler were to be welded onto the sheets below the anchor penetrations. After the corbel installation, the waler was formed and cast against the wall. Proprietary anchorages complete with anti-burst reinforcing were cast into the waler to accept the ground anchor heads.

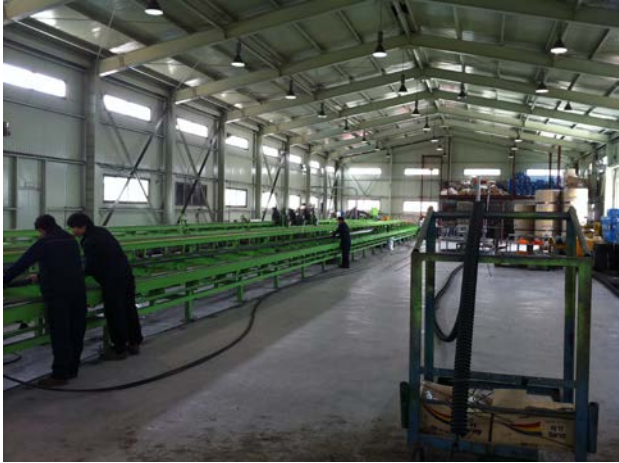
Figure 5: Anchor Production Facility

Each individual strand is run through a specialist greasing and sheathing machine that first opens the individual wires of the strands prior to immersion in a grease bath before completely encapsulating the strand in the outer sheathing thus ensuring no voids are present.

The individual greased and sheathed strands are configured into the design arrangement complete with plastic centralisers over the bare strand in the bond length to create a basket weave, and, a grout hose and nose cone added.

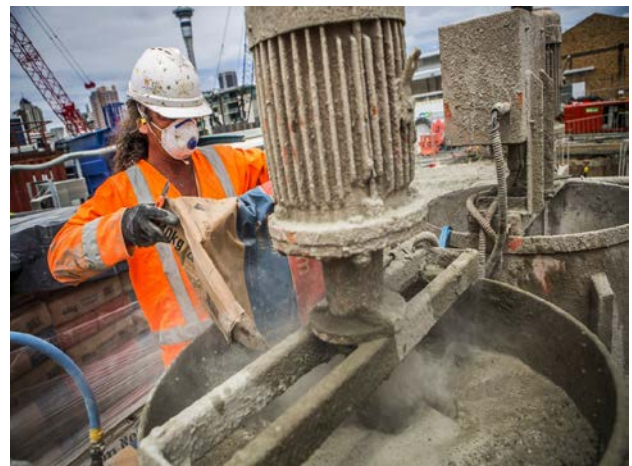
Figure 7: Grouting Station

Grouting comprised neat cement grout with a max water:cement ratio of 0.4. Grout bleed requirements were less than 2%.

Reconciliation of grout volumes in conjunction with visual checks on the level of the top of the grout was required to ensure adequate anchorage along the bonded length was maintained.

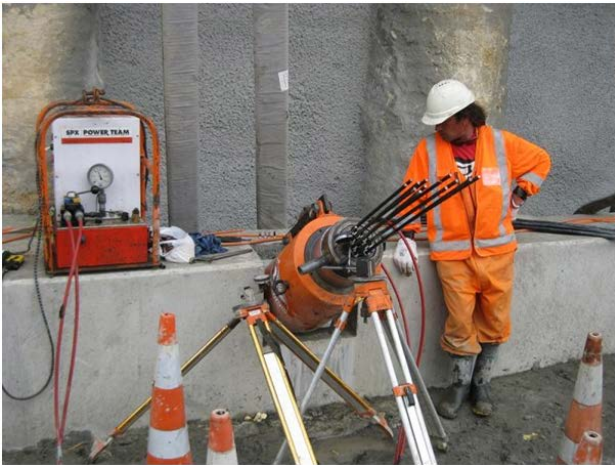
Figure 8: Typical Stressing Set Up

The anchors were proof-tested to 1080kN (125% of working load) to confirm adequate capacity and then post-tensioned to 520kN (60% of working load) to provide the desired level of lateral restraint.

Displacements at each load increment was recorded using a dial gauge atop a remote tripod and at the end of the peak load cycle, creep monitoring was recorded over a 15minute hold period.
